SAILOR

Service Information No. 53
Kundendienst-Mitteilung No.
Service Information No.
Información de servicio No.
Servicemeddelelse No.

Date / Datum / Date / Fecha / Dato October 1973

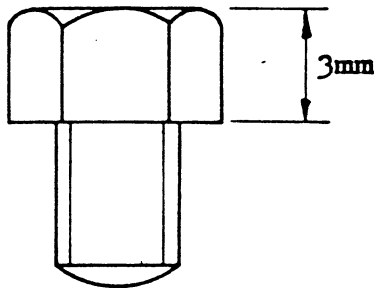
Old type

is only to be used in transmitters with a serial no. lower than 102070.

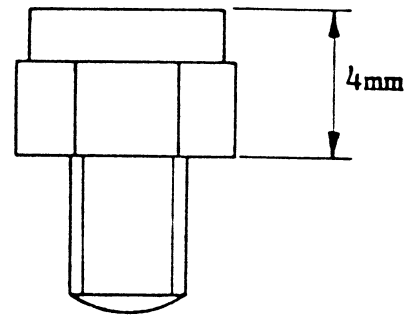
New type

is only to be used in transmitters with a serial no. from 102070 and onwards.

A) Larger distance between contacts in the drum change-over switch and consequently introduction of a new type of contact screws (the small yellow plastic screws that are delivered along with each transmitter).
