# SAILOR

Service Information No.  
 Kundendienst-Mitteilung No.  
 Service Information No. 61  
 Información de servicio No.  
 Servicemeddelelse No.

Date / Datum / Date / Fecha / Dato February 1975

Supplement to point 7, Chapter C IV, Adjustment of AERIAL TUNE, LOAD and INTERNAL DRIVE in the instructionbook for T124.

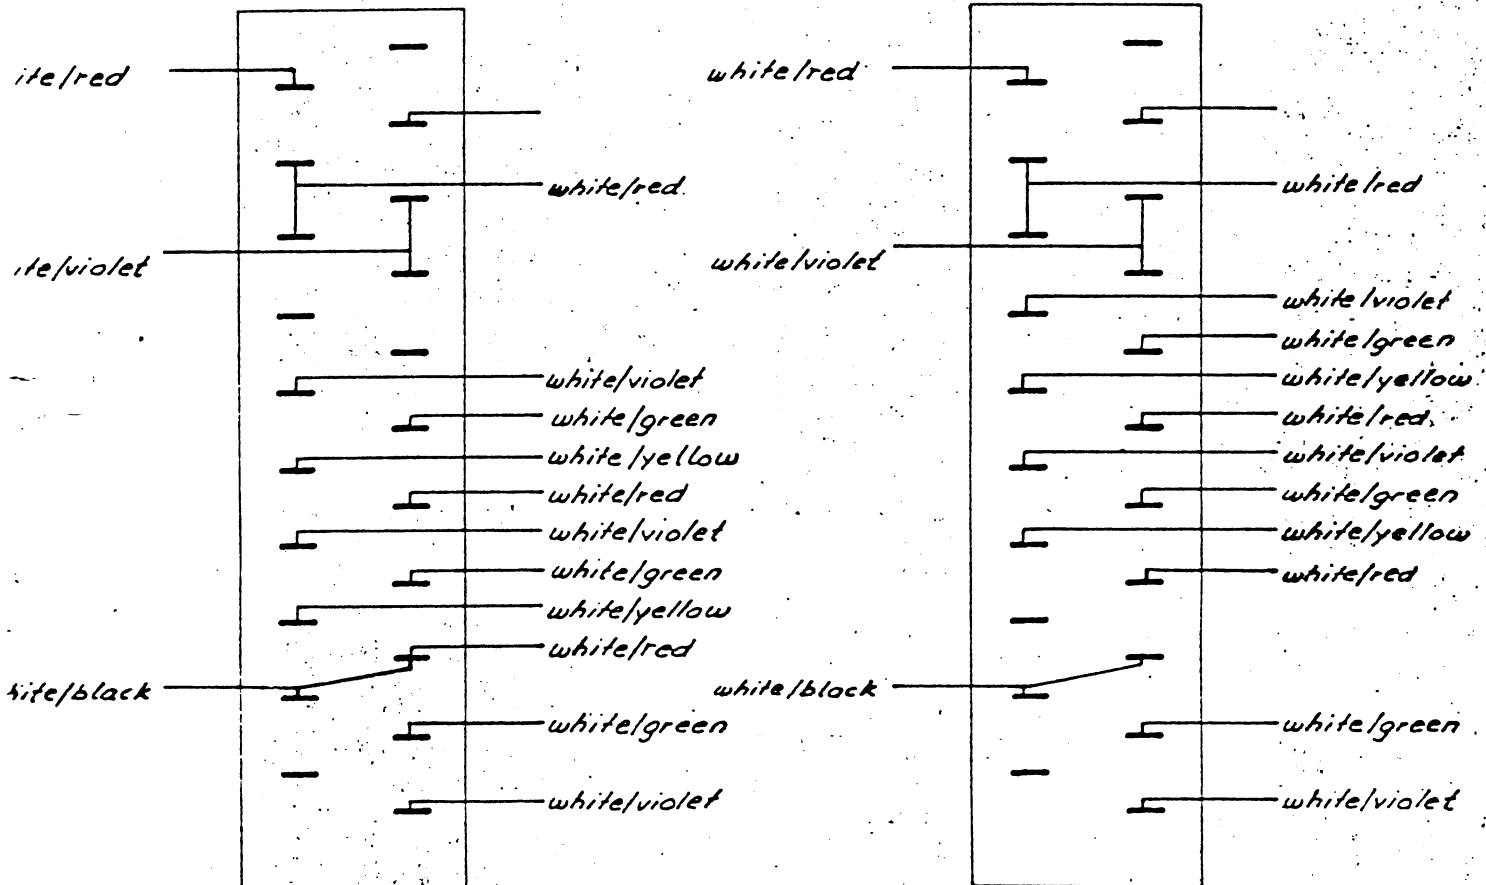
If it is not possible to bring the meter close to the zero line, like described under point 7 (the pointer of the meter is to the right of the zero line, even with contact 31 activated), this can be remedied by moving all coupling steps, 2 steps down, by soldering as shown below.

Capacitor before soldering.

Capacitor after soldering.
