SAILOR

Service Information No. 97
Kundendienst-Mitteilung No.
Service Information No.
Información de servicio No.
Servicemeddelelse No.

Date / Datum / Date / Fecha / Dato August, 1985

T2031 FREQUENCY JUMP OF THE SYNTHESSES

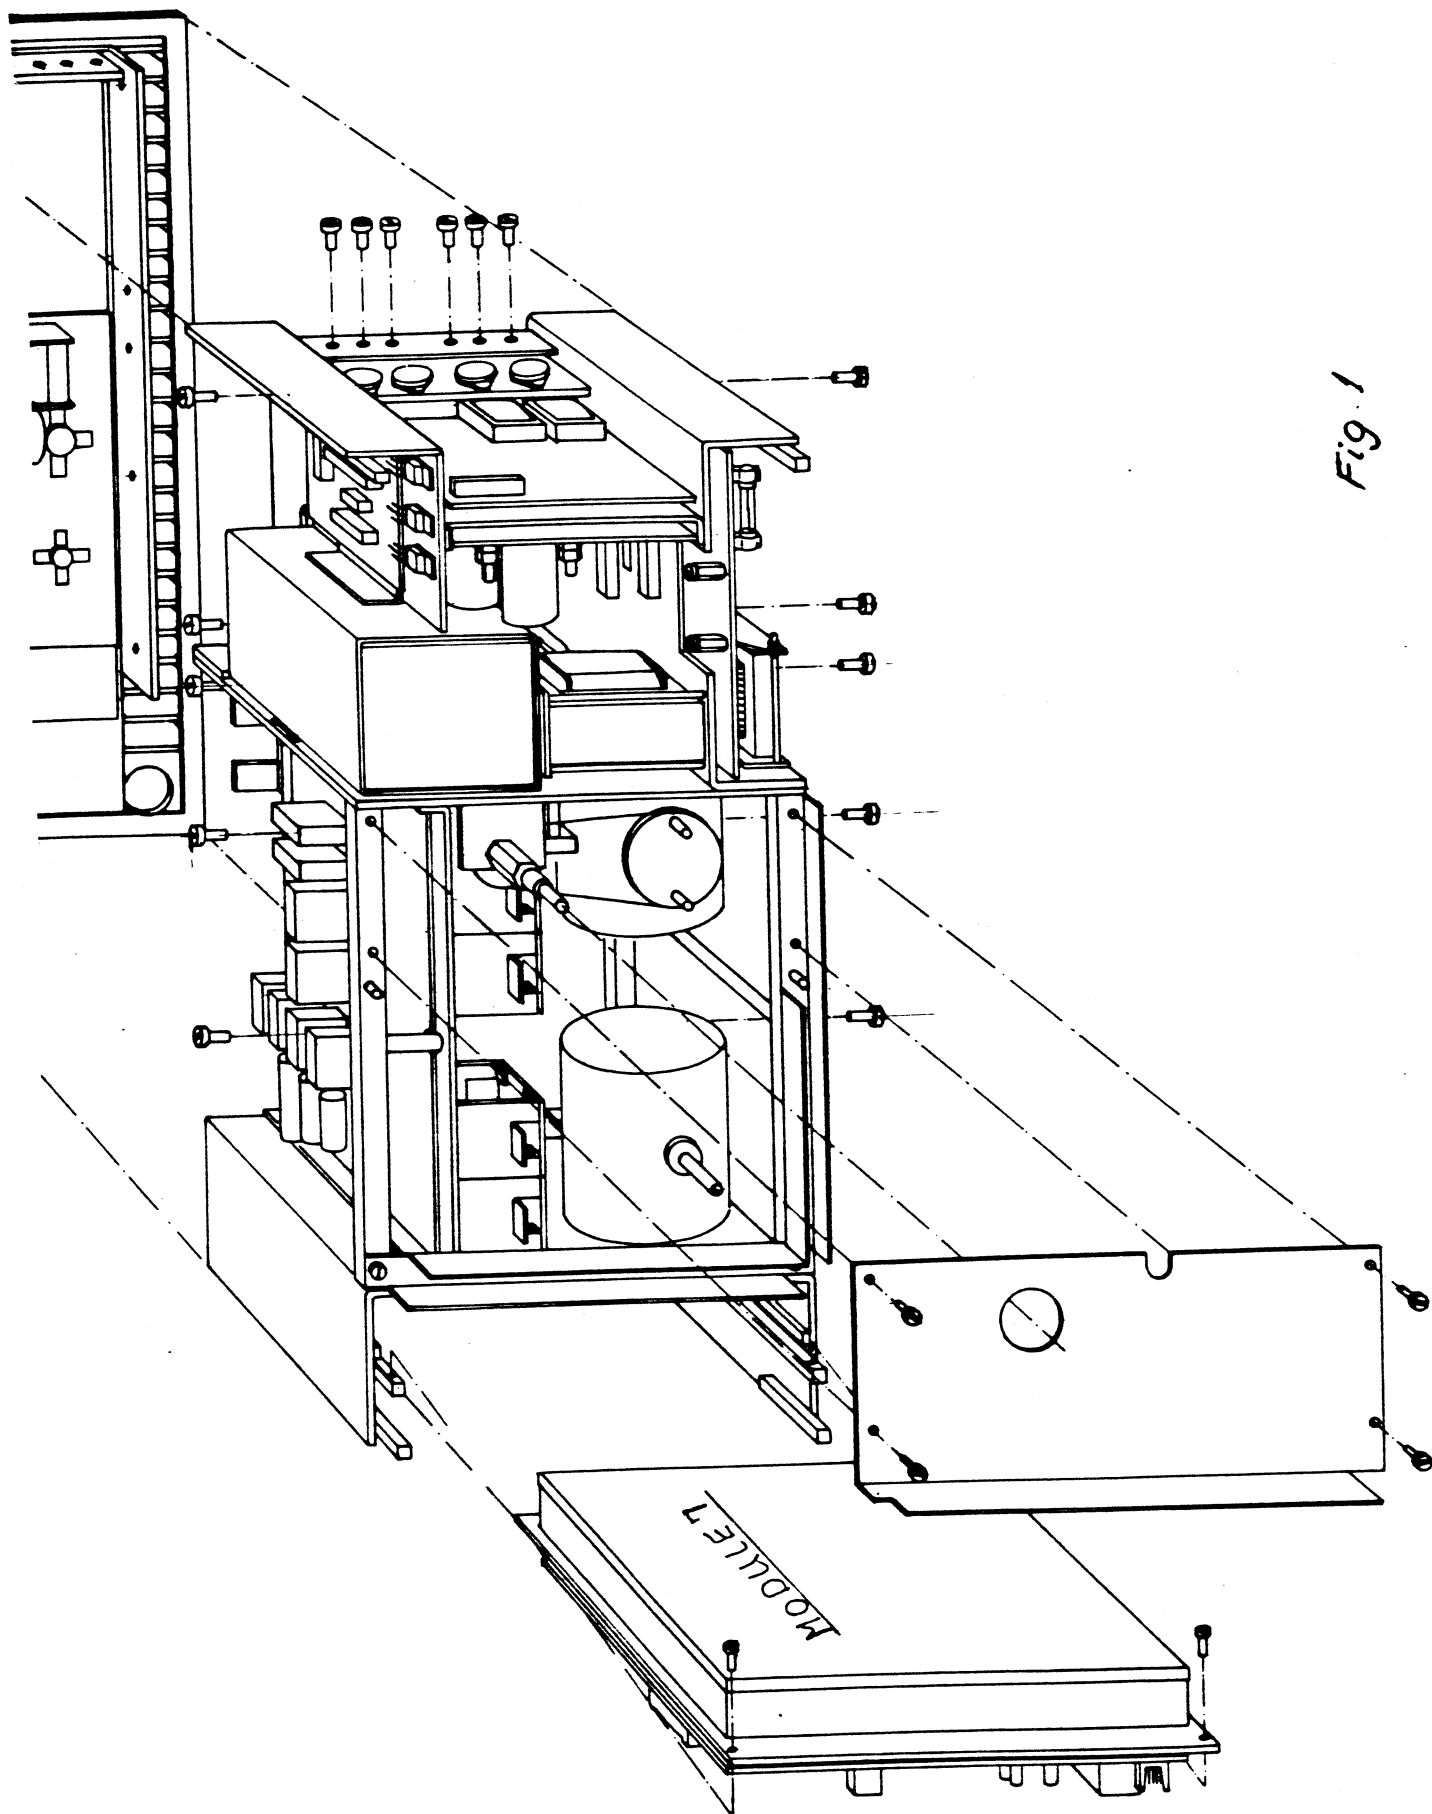
Fig. 1

We have experienced that in some T2031 with serial No. lower than 288017 some synthesis have a decoupling capacitor which is mounted wrongly.

1. Take out the synthesizer module 7 (see fig. 1).
2. Unsolder the capacitor 4n7 marked xx on fig. 2.
3. Solder it in between 0-0 on fig. 2.
4. Remount the module. No adjustment is necessary.
