# Technical News

**SAILOR**

NUMMER 3

FEBRUAR 1995

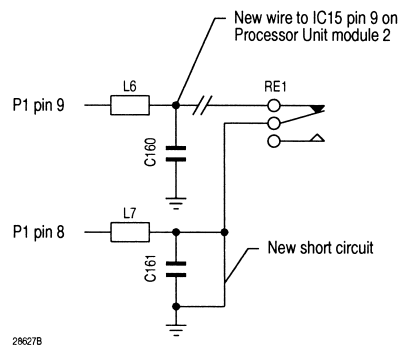
It is necessary to modify the CRY2001 to avoid the RE2100 from going in HF OCC mode, when the Scrambler handset is removed from the hook and STN2 is selected.

After the modification, the CRY2001 will supply 7.5V out on P1 (STN1) pin 9, when STN2 is selected. This will drive Q1 in the hook on STN2 in saturation and thus prevent RE2100/C2140 from going into HF OCC mode.

- A: Disassemble CRY2001 as described in chapter 6.0.
- B: Remove the F&T unit module (1).
- C: Locate the coil L6 and the relay RE1.
- D: Cut the wire on the PCB (component side) between RE1 and L6.

- E: Solder a wire from the conjunction of L6/C160 to IC15 pin 9 on the Processor Unit module 2.
- F: Solder a wire from the conjunction of L7/C161 to ground (across the C161) so that P1 pin 8 is grounded.
- G: Reassemble the CRY2001, connect all cables and perform a function check on all units.

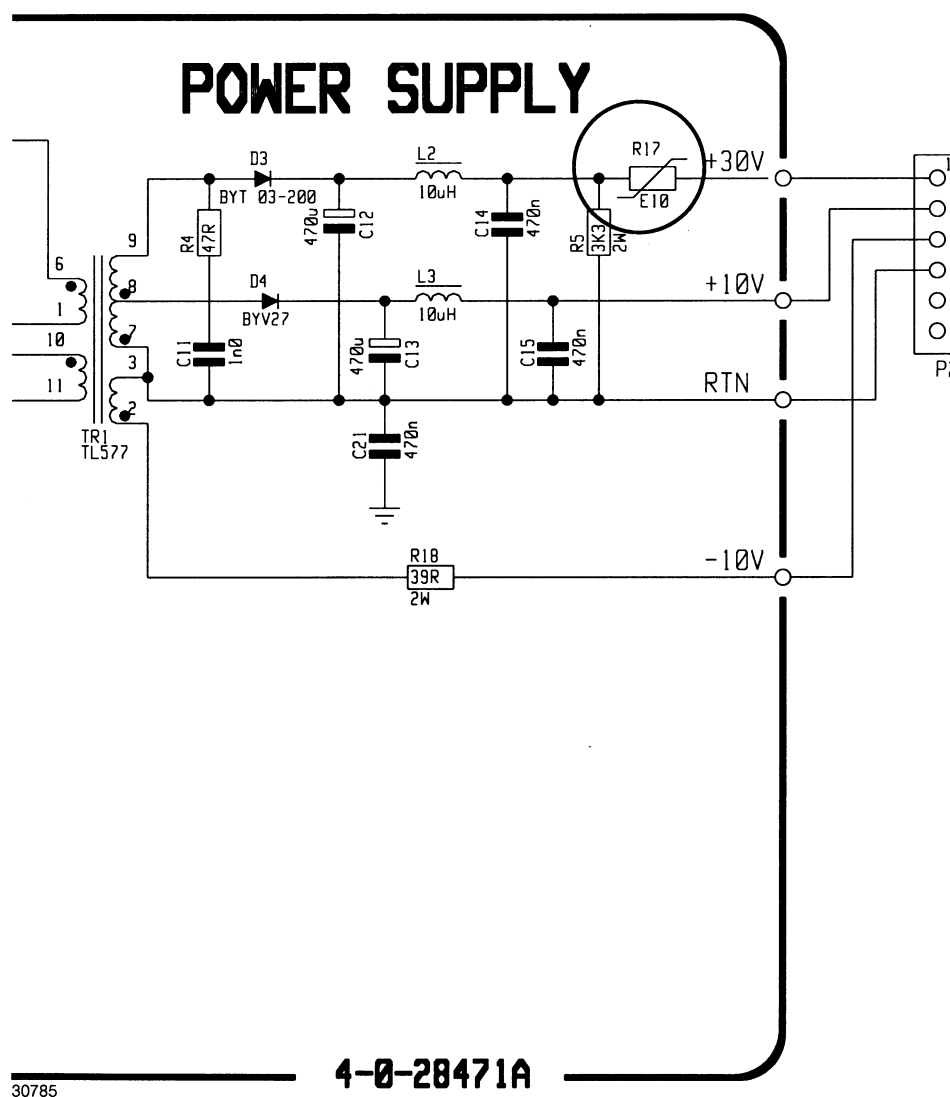
This diagram is valid for PCB rev. 28471C

Det er konstateret en forøget fejlfrekvens på DC printere med strømforsyningen (SP nr. 628471), som er vist på vedlagte side, tegning nr. 4-0-28471. Tegningsnummeret findes også på printet.

Fejlen viser sig ved, at dioden D3 kortslutter.

Gentagne fejl undgået ved at montere en autosikring (SP nr. 07162), som vist på vedlagte diagram og printtegning. Autosikringen er en PTC modstand fra Bourns (MR-R-110).

Ved printere med ovennævnte strømforsyning skal kortslutningen over D28 (D10) fjernes, idet denne kortslutning kan forårsage afbrænding af dioden D3 på DC strømforsynings printet.

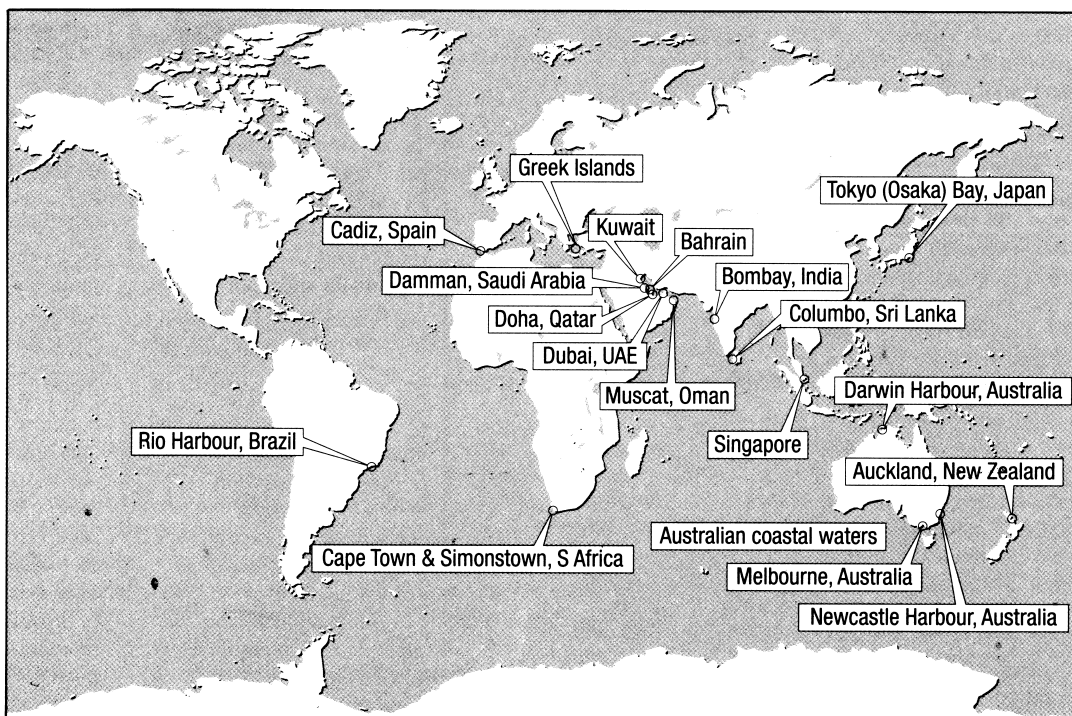
Locations where interference has been reported are outlined on the map below. If you have experienced problems in any other areas, please let Brian Garstang know by writing to him at Inmarsat HQ or contacting him on, tel: +44 71 728 1055. ■

*Interference areas tend to be small (approximately 10km at the most) and also tend to be located in harbours where several ships are in close proximity.*

This can sometimes be overcome by pointing the antenna away from the source of the interference and using an alternative satellite.

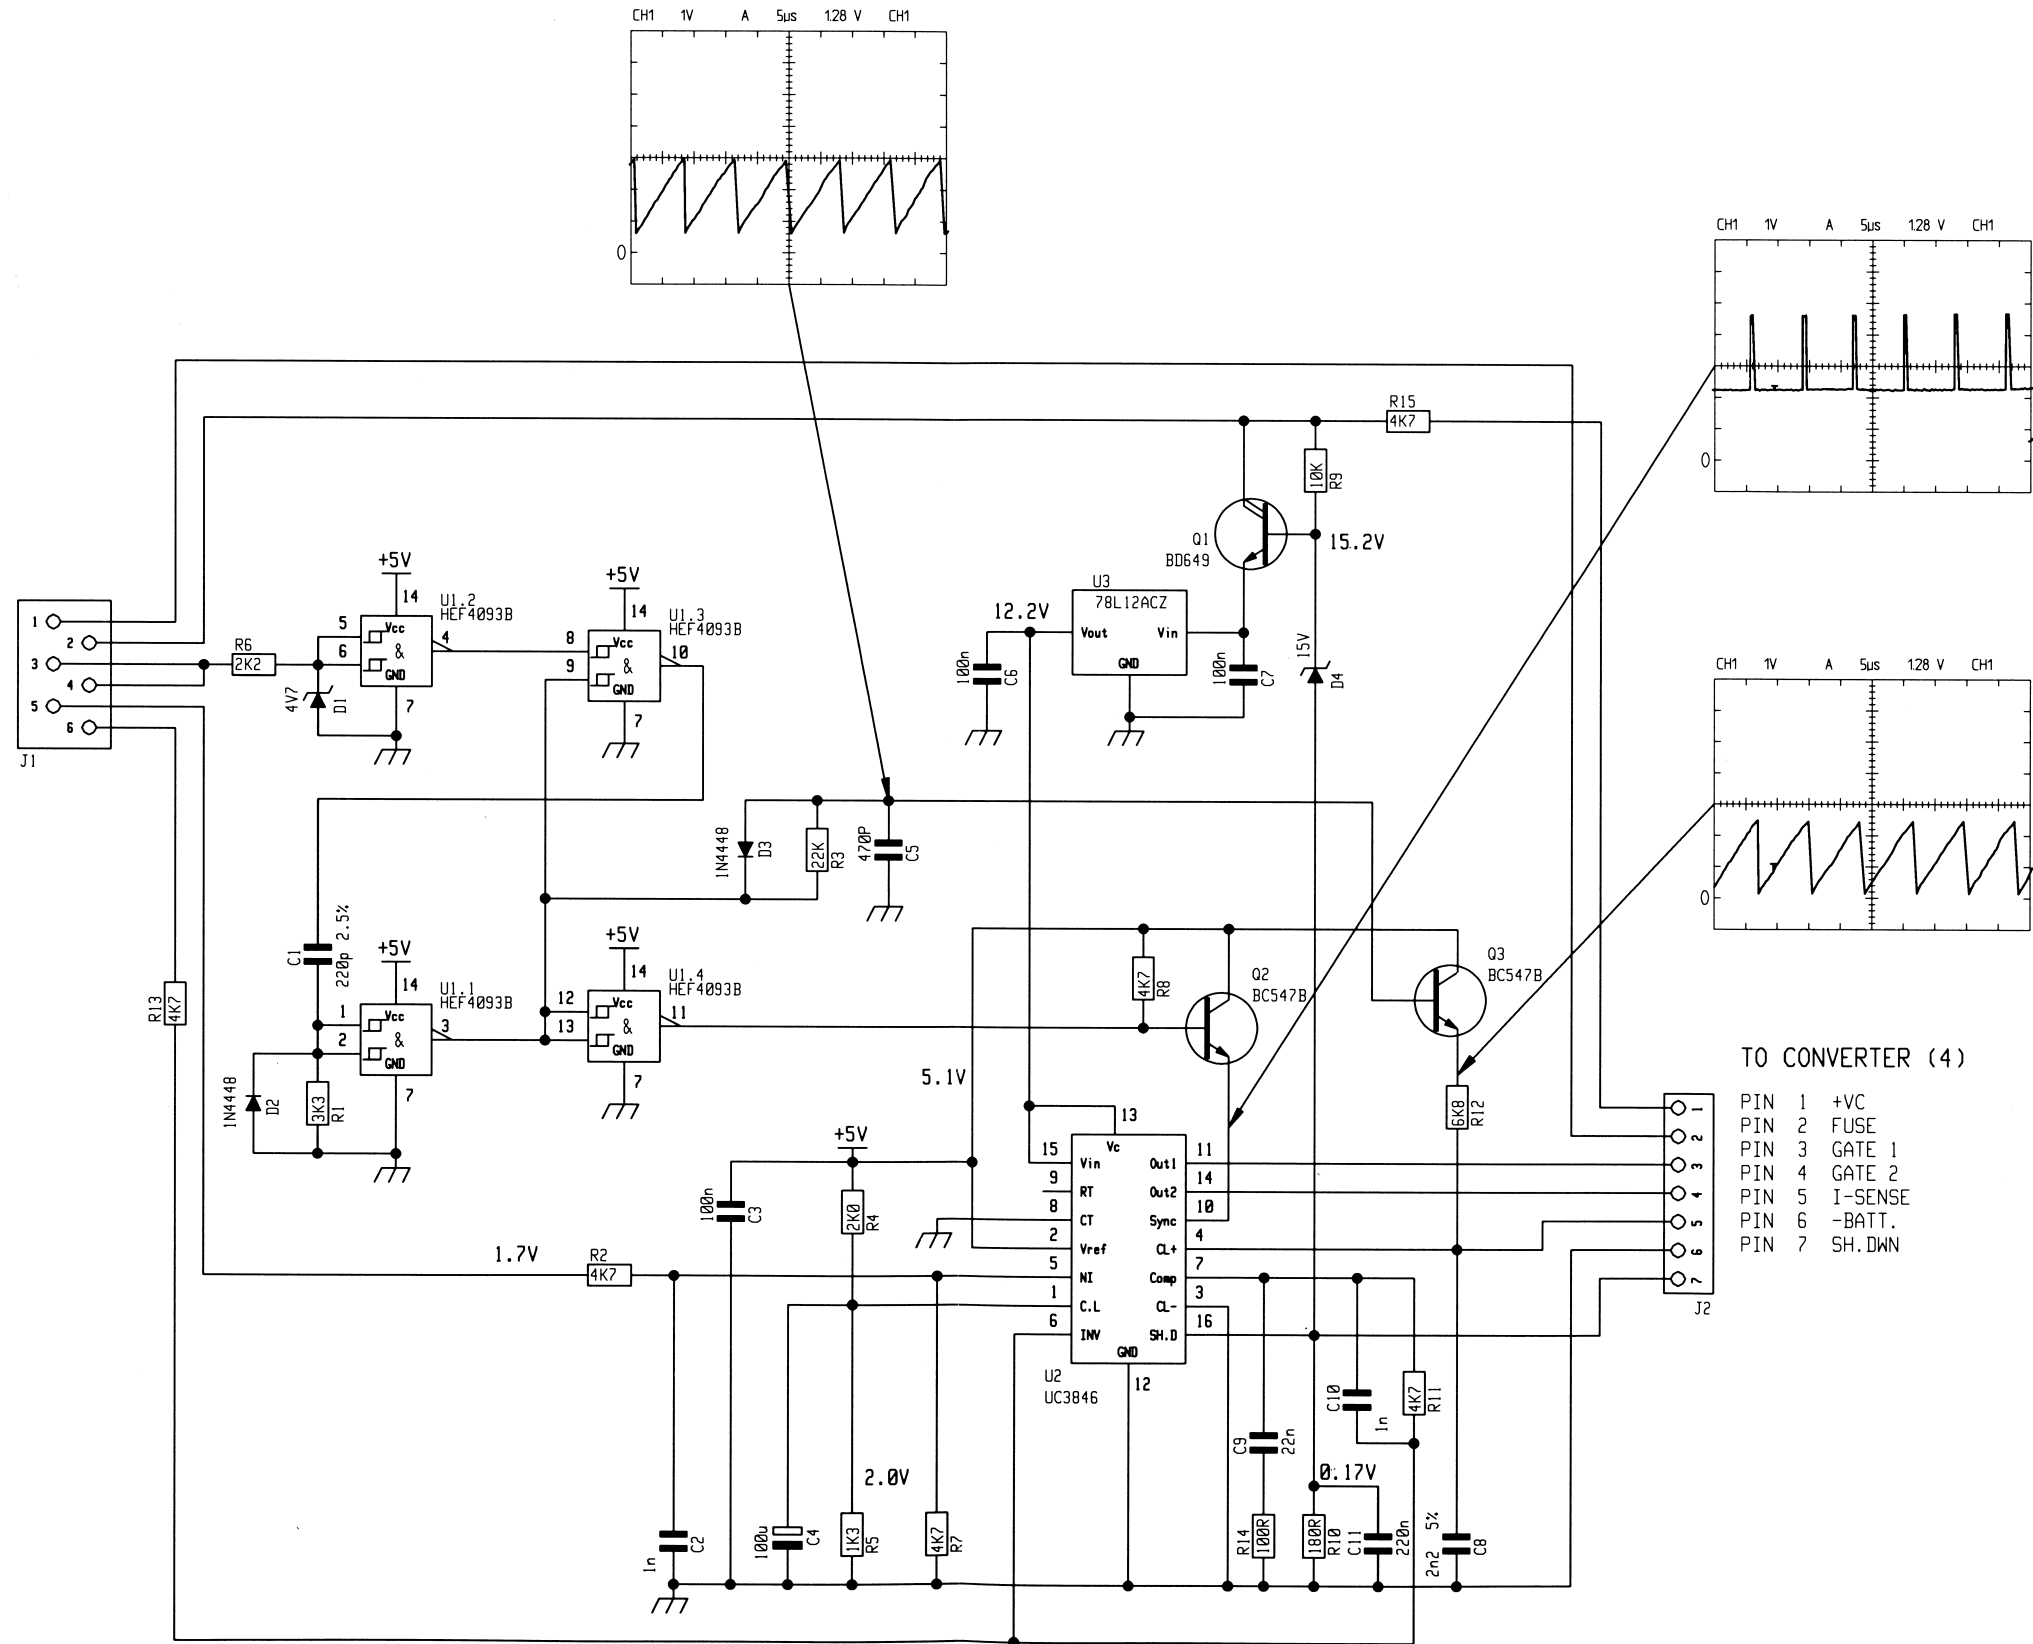
CONVERTER CONTROLLER MODULE 3

Det har vist sig, at enkelte strømforsyninger N2170 ikke starter ved aktivering, samt at enkelte N2170 ikke leverer fuld effekt.

Årsagen til begge fejl kan være støj på inputspændingen til sense indgangen på U2 på converter controller modulet.

Fejlen afhjælpes ved at montere en 220 nf. kondensator over R10, som vist på vedlagte diagram og printtegning.

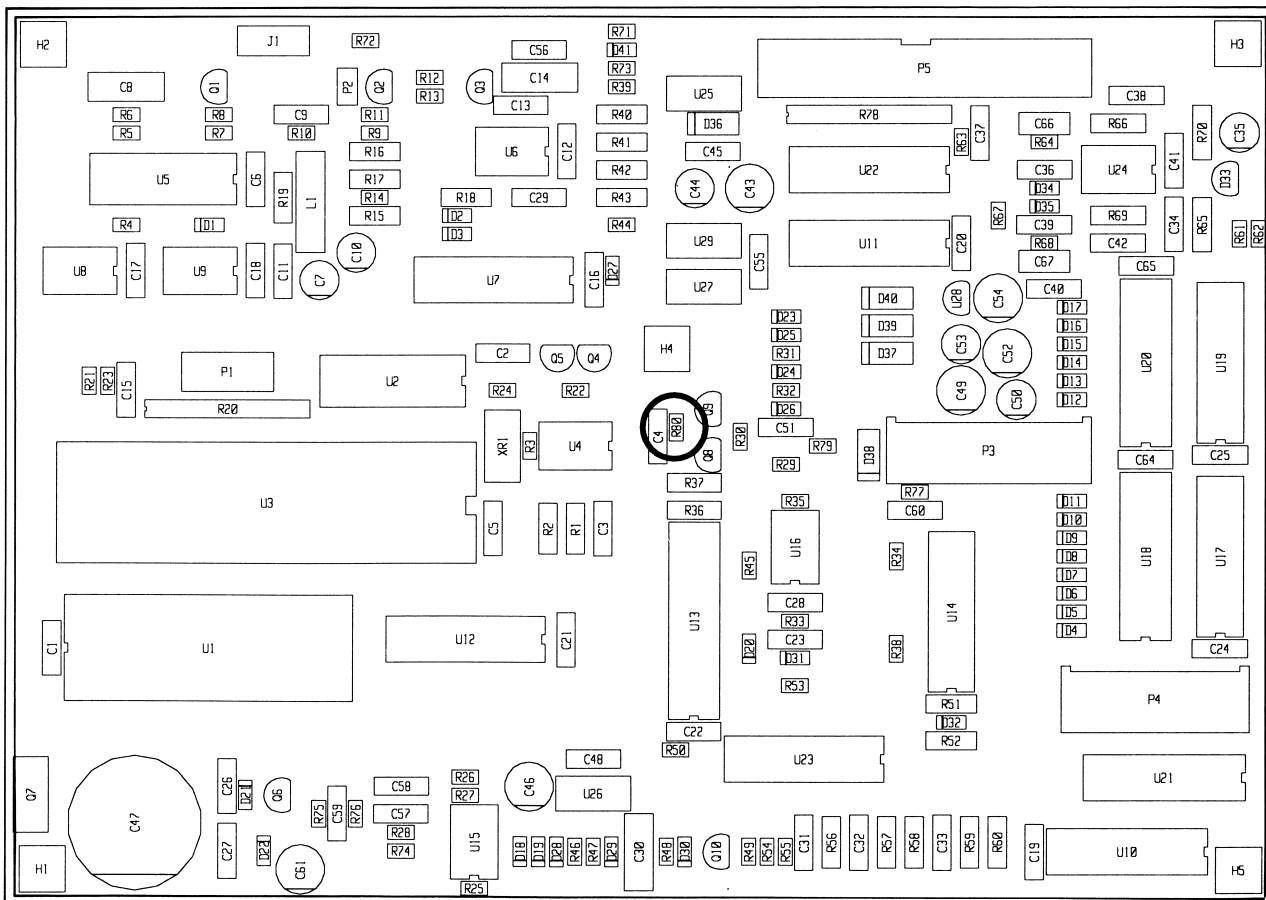
# COMPONENT LOCATION TX PROCESSOR MODULE 8

På TX-Processor board modul 8 er modstanden R80 ændret til 100 Ohm. Dette medfører, at TX-Processor modul 8 version 626408EH kun kan anvendes sammen med connection board modul 14 version "N" eller højere.
