The technical bulletin board of SKANTI

Technical Information

Referred products:

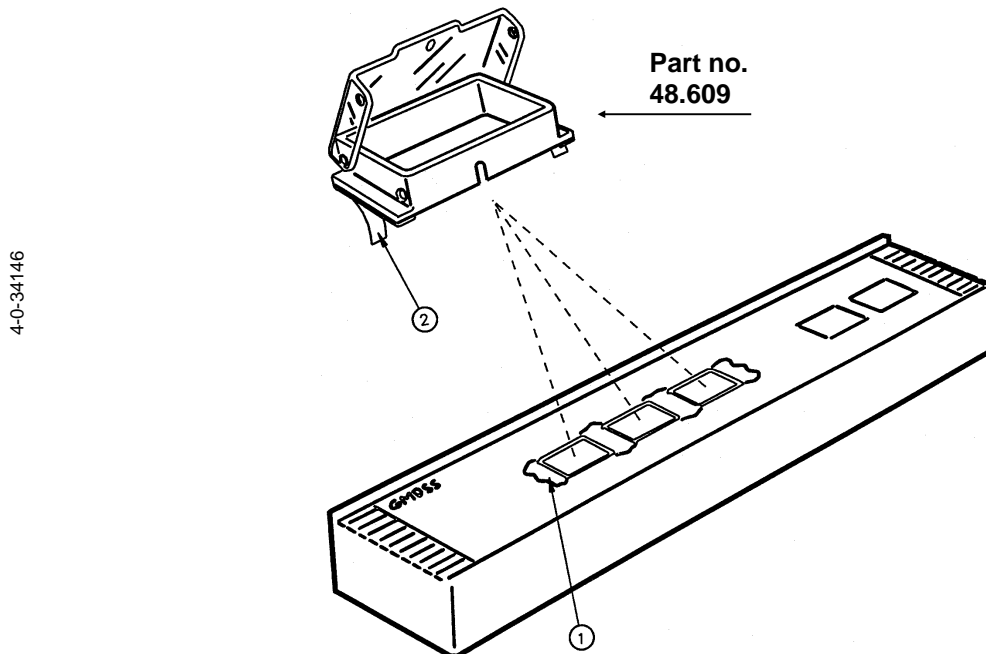
Fitting the key cover

The IMO has revised the requirements on distress buttons in order to reduce the number of false alerts. The revised requirements which will be effective from the 23rd of November 1996, specify that the distress button should be protected against inadvertent operation and that distress alert initiation should require at least two independent actions. These requirements are specified in A.803(19) 2.7.2 and 2.8 for VHF, A.804(19) 2.6.2 and 2.7 for MF, A.806(19) 2.6.2 and 2.7 for MF/HF and A.807(19) 3.4.2 and 3.5 for INM-C.

1. Clean the two marked parts(1) of the keypad using isopropyl alcohol.
2. Remove the protective paper from the key cover(2).
3. Carefully align and fit the key cover over the transmit keys.

CAUTION: Do not touch the key cover for 24 hours unless a distress situation occurs.
Key cover part no.: **48.609**

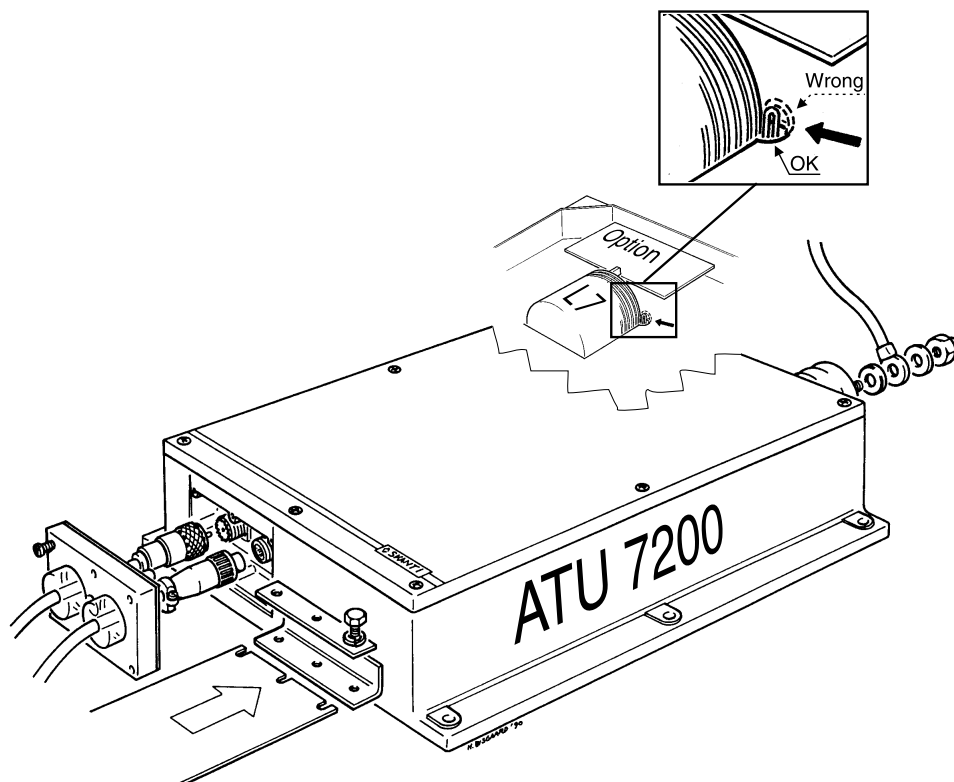
The problem is the bending of the L7 coil wire where routed to the bottom side of the board. If the wire bending is not sufficiently sharp (indicated on fig. by dashed lines), it may cause sparks inside the ATU.

We recommend that an ATU 7200 which has a serial no. in the listed range is checked for this problem before installation. If the ATU is already installed the check should be performed on the next service call.

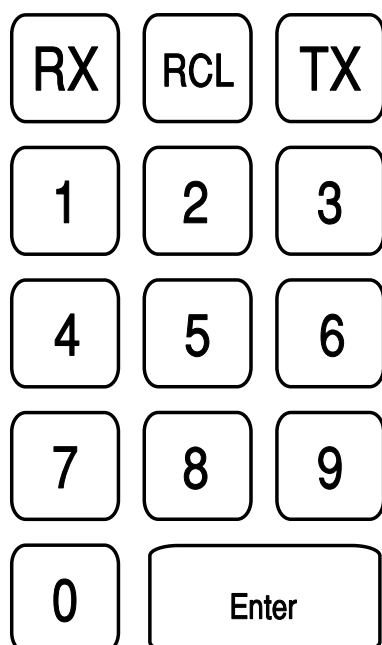
New Numeric Keyboard:
CCITT Type

In connection with our new design of CU 8000 (updated front and colour) we have a different location of the numbers on the Control Unit Numeric Keyboard (Membrane Overlay)

This means: If the old type of keyboard is replaced with the new type then the Configuration E-PROM inside the Control Unit also must be replaced or re-programmed to ensure harmony between the activated key and the displayed number .
