Product: TRP 1250 / TRP 9250

**SUBJECT: Power Off problem**

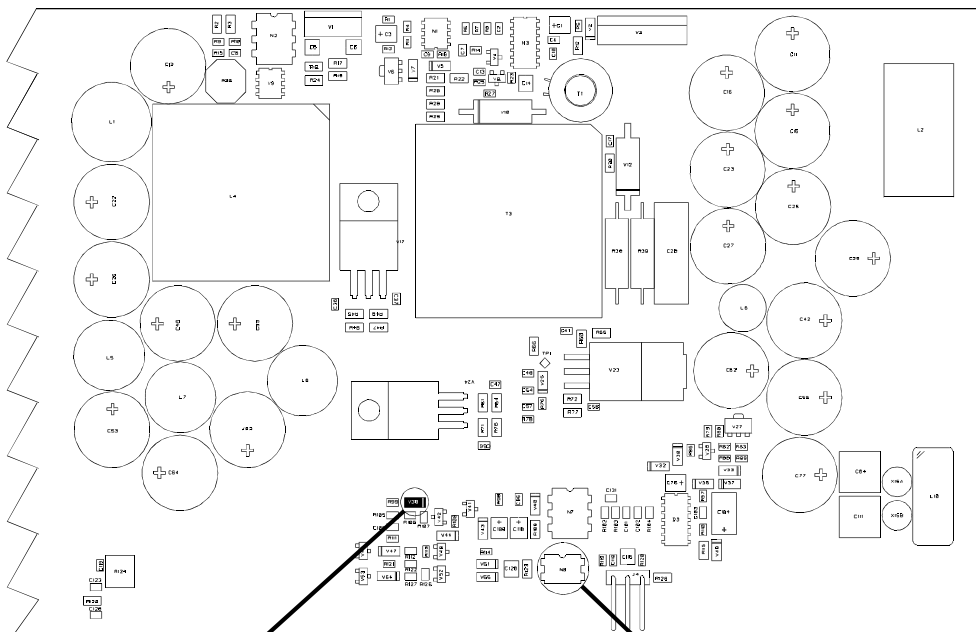
**DC POWER SUPPLY
INTERFACE BOARD 935
VERSION C
VIEWED FROM
COMPONENT SIDE**

Please be advised that Skanti A/S has seen a Power Off problem on some installations with TRP 1250 and TRP 9250 MF/HF radios. The problem has been traced to a reversed Zener diode V39 and a missing 470 pF ceramic capacitor. The problem can be rectified by following the description below:

Inspect that diode V39 is mounted correct. Marking must be as indicated below.

If not the diode must be turned.

Place a 470 pF ceramic capacitor on top of the housing of N8. Solder it to the two pins as indicated below:
