# SAILOR

Service Information No. 68  
Kundendienst-Mitteilung No.  
Service Information No.  
Información de servicio No.  
Servicemeddelelse No.

Re.: Transmitters T121, T124, T126 and T128

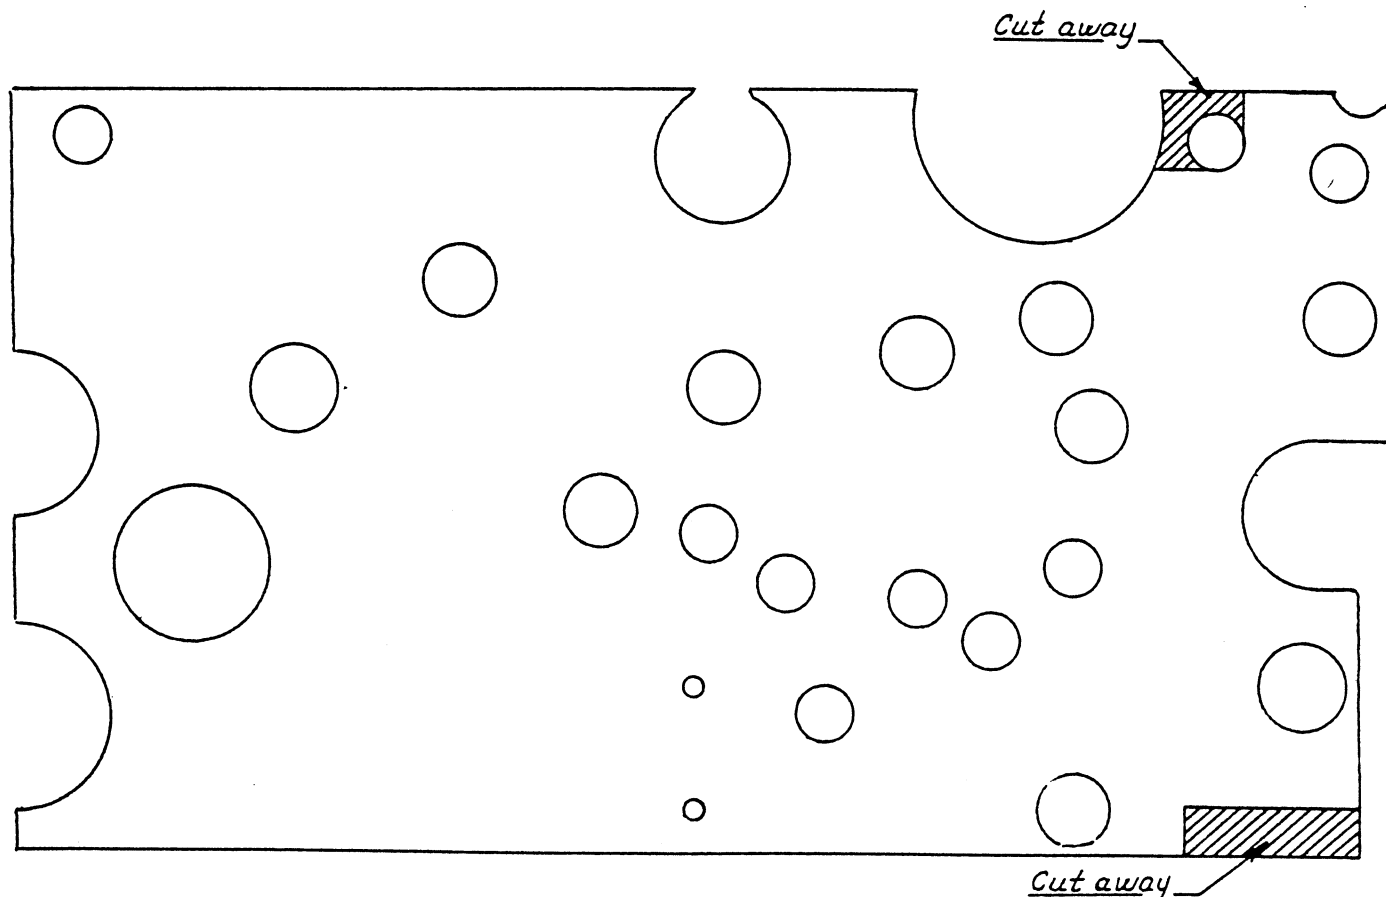
If the 18 V supply in the power supplies for the mentioned transmitters is faulty, please check if the fault is caused by the screen plate below the SSB generator.

It is recommended to cut the screen plate so that the possibility for short circuit of the 18 V supply is eliminated.
