# Technical News

**SAILOR**

NUMMER 3

FEBRUAR 1995

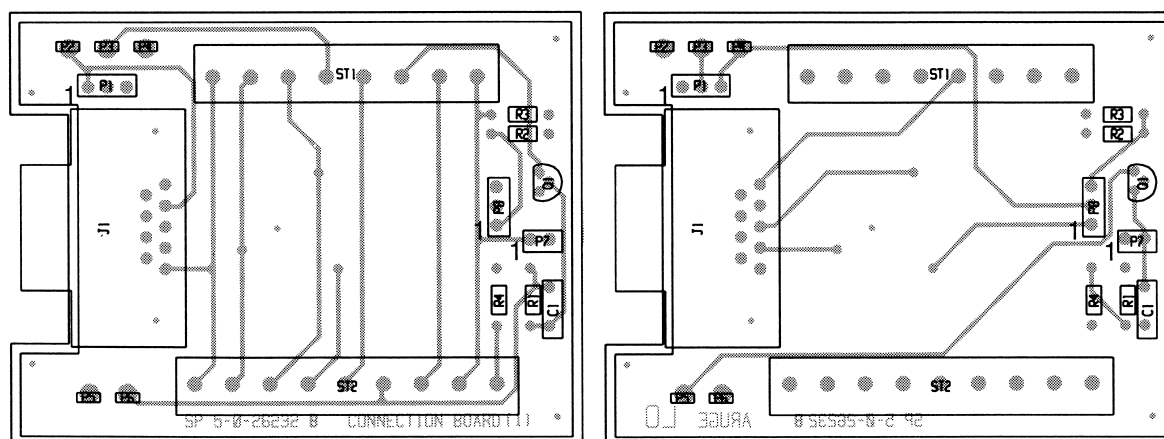
CRY2001 C

**NOTE! Remember to modify the Scrambler CRY2001 (STN1 input) and the Receiver RE2100.**

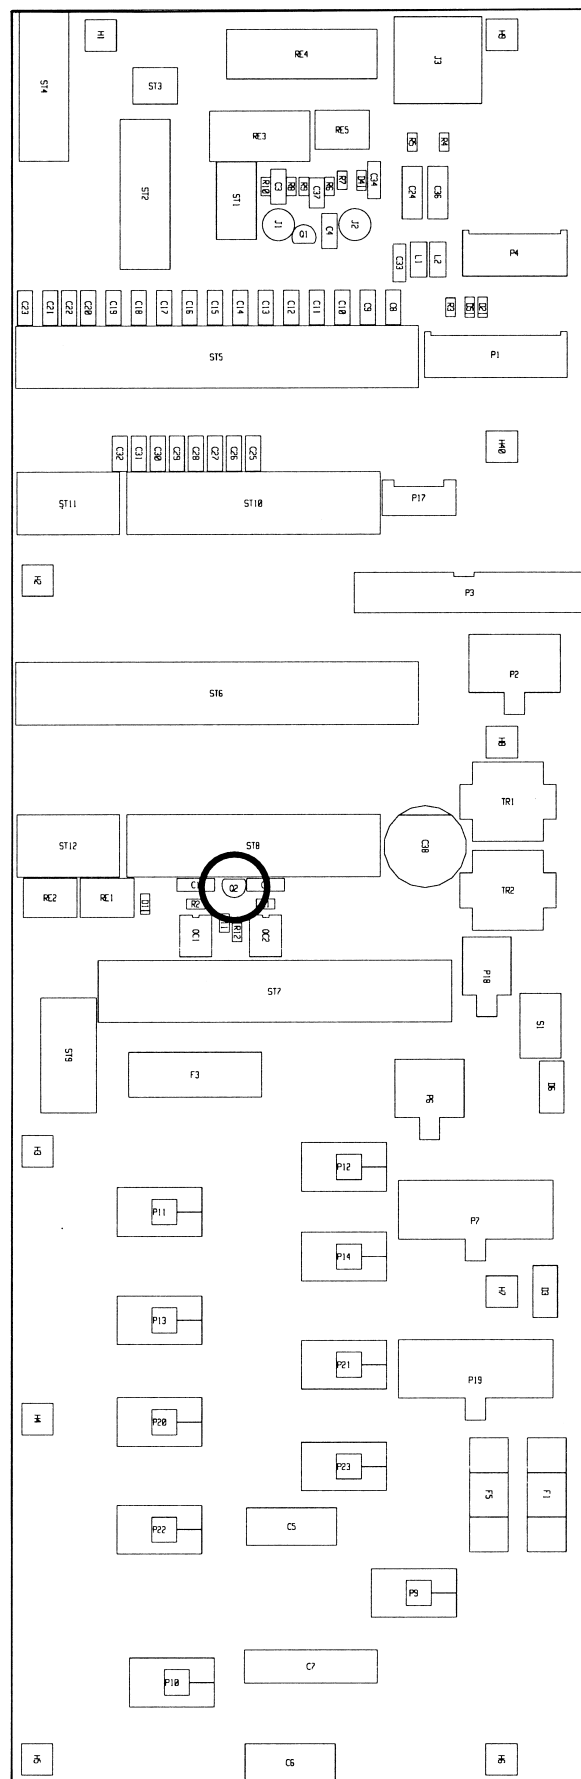
### CONNECTION BOARD MODULE 14

På TX-Processor board modul 8 er modstanden R80 ændret til 100 Ohm. Dette medfører, at TX-Processor modul 8 version 626408EH kun kan anvendes sammen med connection board modul 14 version "N" eller højere.
